YOUR ONESURVEY  
**HOME REPORT**

56 Victoria Street  
Dunfermline  
KY12 0LP

# SINGLE SURVEY

# Single Survey

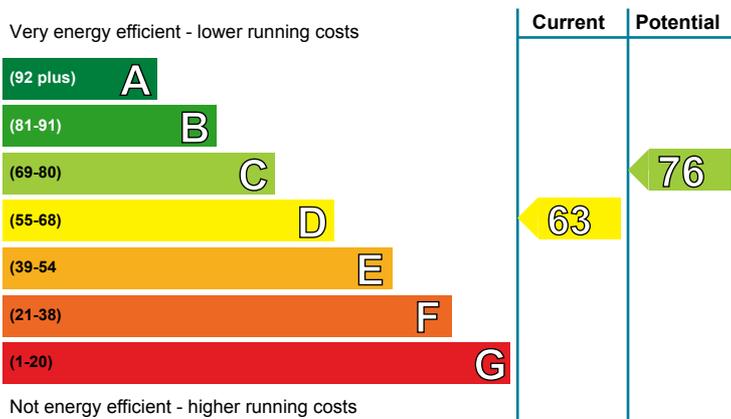
## Energy Efficiency Rating

This graph shows the current efficiency of your home, taking into account both energy efficiency and fuel costs. The higher this rating, the lower your fuel bills are likely to be.

Your current rating is **band D (63)**. The average rating for EPCs in Scotland is **band D (61)**.

The potential rating shows the effect of undertaking all of the improvement measures listed within your recommendations report.

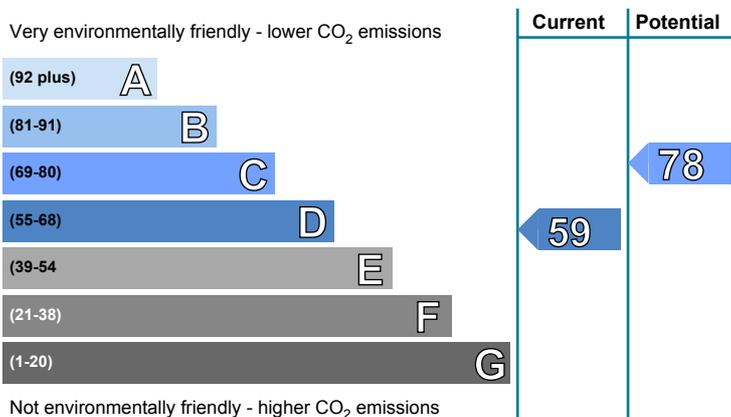
## Environmental Impact (CO<sub>2</sub>) Rating

This graph shows the effect of your home on the environment in terms of carbon dioxide (CO<sub>2</sub>) emissions. The higher the rating, the less impact it has on the environment.
