# HOME REPORT

Broomfield House  
Foulford Road  
COWDENBEATH  
KY4 9AP

**DM HALL**  
CHARTERED SURVEYORS

# Single Survey

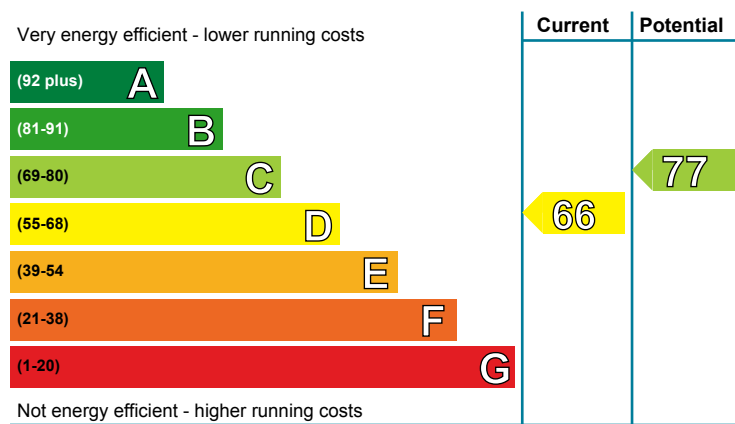
## Energy Efficiency Rating

This graph shows the current efficiency of your home, taking into account both energy efficiency and fuel costs. The higher this rating, the lower your fuel bills are likely to be.

Your current rating is **band D (66)**. The average rating for EPCs in Scotland is **band D (61)**.

The potential rating shows the effect of undertaking all of the improvement measures listed within your recommendations report.

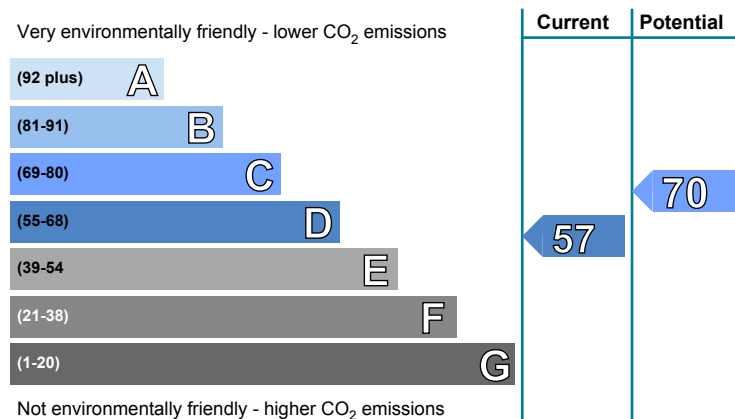
## Environmental Impact (CO<sub>2</sub>) Rating

This graph shows the effect of your home on the environment in terms of carbon dioxide (CO<sub>2</sub>) emissions. The higher the rating, the less impact it has on the environment.
