# HOME REPORT

5 Burnbank Meadows  
KINROSS  
KY13 8GE

# Single Survey

<b>Property address</b>	5 Burnbank Meadows, KINROSS, KY13 8GE
-------------------------	---

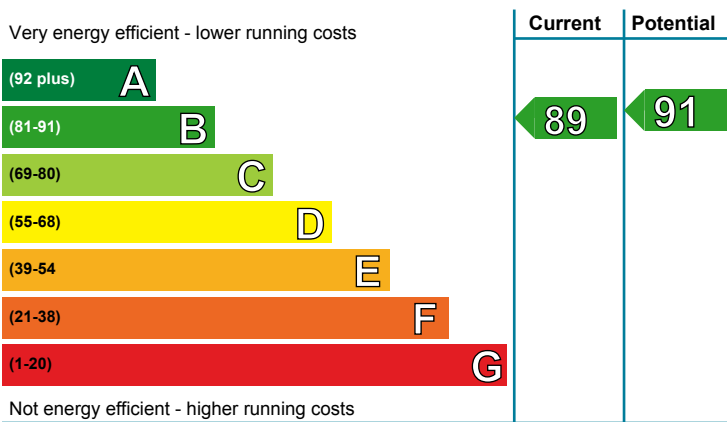
## Energy Efficiency Rating

This graph shows the current efficiency of your home, taking into account both energy efficiency and fuel costs. The higher this rating, the lower your fuel bills are likely to be.

Your current rating is **band B (89)**. The average rating for EPCs in Scotland is **band D (61)**.

The potential rating shows the effect of undertaking all of the improvement measures listed within your recommendations report.
