HOME REPORT

Single Survey

Property address	RANNOCH, 64 MONTGOMERY STREET, KINROSS, KY13 8EB
-------------------------	-----------------------------------------------------------

Date of inspection	10th January 2024
---------------------------	-------------------

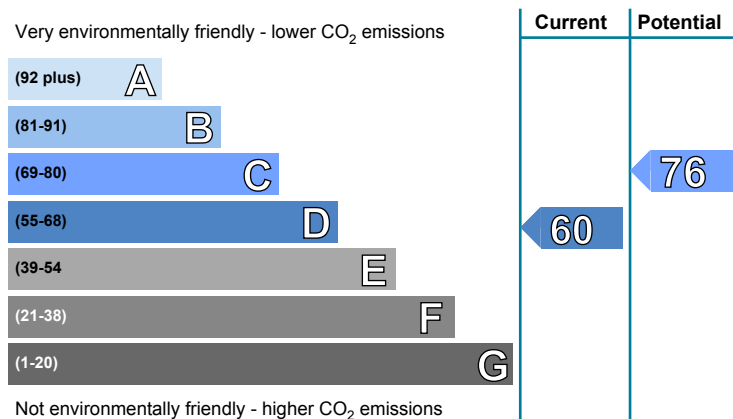
Environmental Impact (CO₂) Rating

This graph shows the effect of your home on the environment in terms of carbon dioxide (CO₂) emissions. The higher the rating, the less impact it has on the environment.
