HOME REPORT

1 Rannoch Place
KINROSS
KY13 8BQ

DM HALL
CHARTERED SURVEYORS

Single Survey

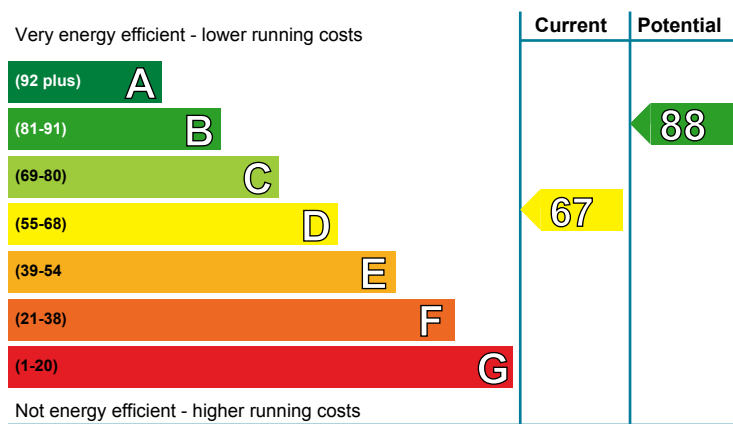
Energy Efficiency Rating

This graph shows the current efficiency of your home, taking into account both energy efficiency and fuel costs. The higher this rating, the lower your fuel bills are likely to be.

Your current rating is **band D (67)**. The average rating for EPCs in Scotland is **band D (61)**.

The potential rating shows the effect of undertaking all of the improvement measures listed within your recommendations report.

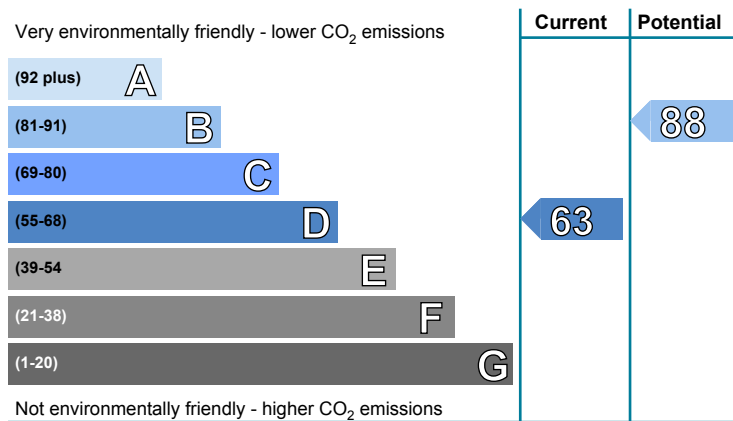
Environmental Impact (CO₂) Rating

This graph shows the effect of your home on the environment in terms of carbon dioxide (CO₂) emissions. The higher the rating, the less impact it has on the environment.
