HOME REPORT

9 Sutherland Drive
KINROSS
KY13 8BJ

DM HALL
CHARTERED SURVEYORS

survey report on:

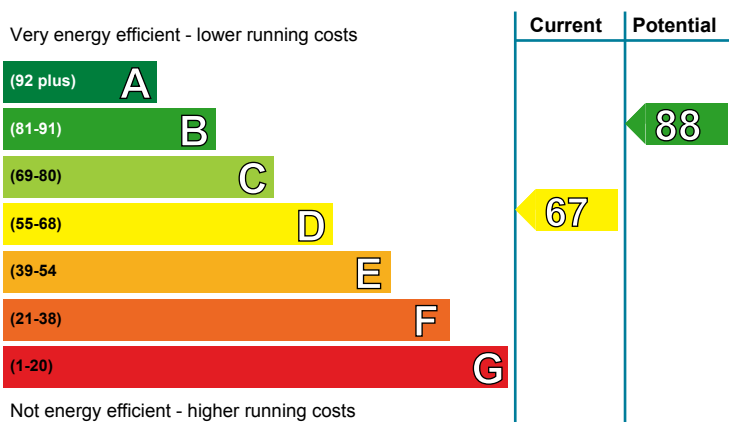
Energy Efficiency Rating

This graph shows the current efficiency of your home, taking into account both energy efficiency and fuel costs. The higher this rating, the lower your fuel bills are likely to be.

Your current rating is **band D (67)**. The average rating for EPCs in Scotland is **band D (61)**.

The potential rating shows the effect of undertaking all of the improvement measures listed within your recommendations report.

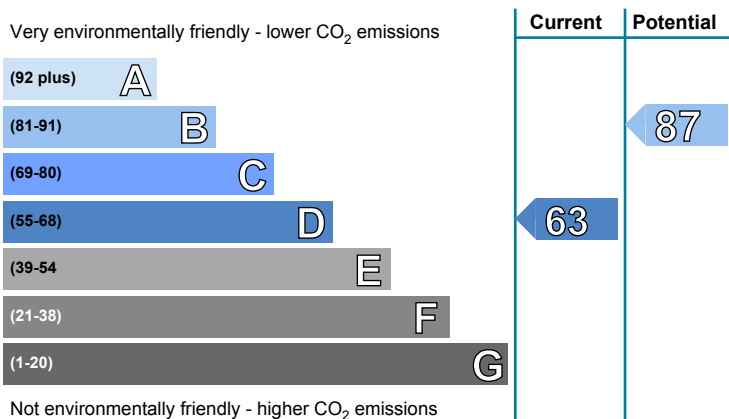
Environmental Impact (CO₂) Rating

This graph shows the effect of your home on the environment in terms of carbon dioxide (CO₂) emissions. The higher the rating, the less impact it has on the environment.
