HOME REPORT

164 Halbeath Road
DUNFERMLINE
KY11 4LB

Single Survey

| Property address | 164 Halbeath Road, DUNFERMLINE, KY11 4LB |

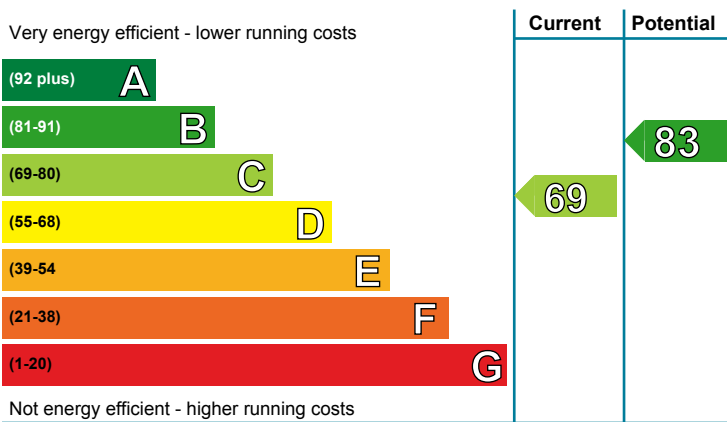
Energy Efficiency Rating

This graph shows the current efficiency of your home, taking into account both energy efficiency and fuel costs. The higher this rating, the lower your fuel bills are likely to be.

Your current rating is **band C (69)**. The average rating for EPCs in Scotland is **band D (61)**.

The potential rating shows the effect of undertaking all of the improvement measures listed within your recommendations report.

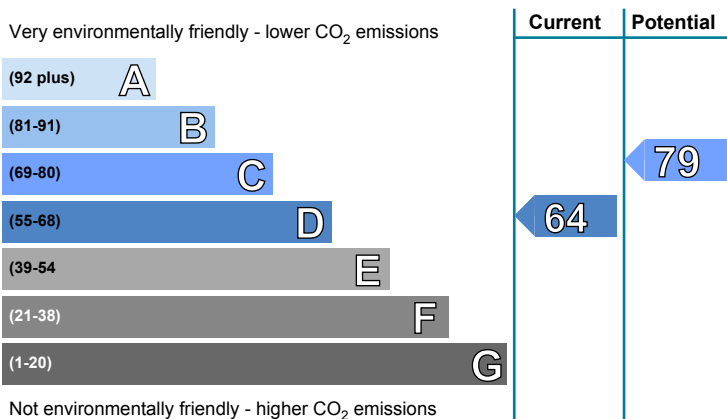
Environmental Impact (CO₂) Rating

This graph shows the effect of your home on the environment in terms of carbon dioxide (CO₂) emissions. The higher the rating, the less impact it has on the environment.
